(NASA-CR-120265)	REPORT ON SKYLAB -M552	N74-28988
SAMPLES (Battelle Columbus Labs., Ohio.)		
20 p HC \$4.00	CSCL 11F	
19		Unclas
		G3/17 15981

REPORT ON SKY LAB-M552 SAMPLES  
CONTRACT NO. NAS-8-28725

This report summarizes the work conducted on M552 samples at Battelle's Columbus Laboratories since July 18.

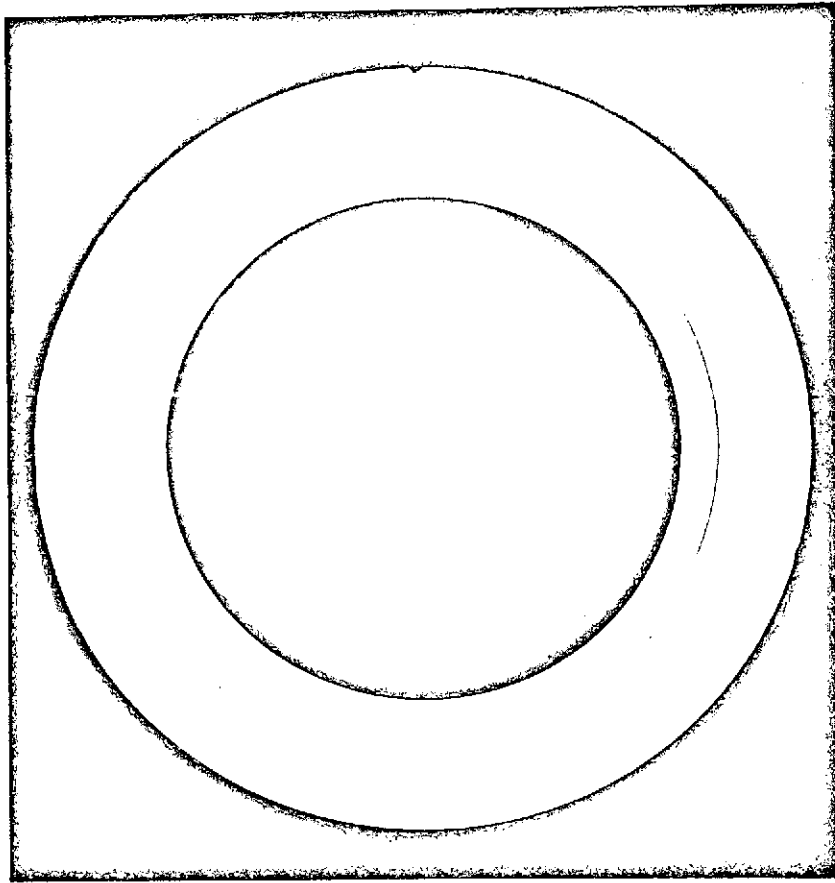
FIGURE III-1. SECTION SLS-1.2(3mm)

Figure III-1<sup>(a)</sup> shows the appearance at 3 mm (1.2). This section is between the igniter end of the sleeve and the adjacent ring groove. Sections at 0, 31, and 35 mm were similar in appearance. Some idea of the gap variations is evident: compare the thickness at 45 degrees and 235 degrees. A very small void is present at 235 degrees.

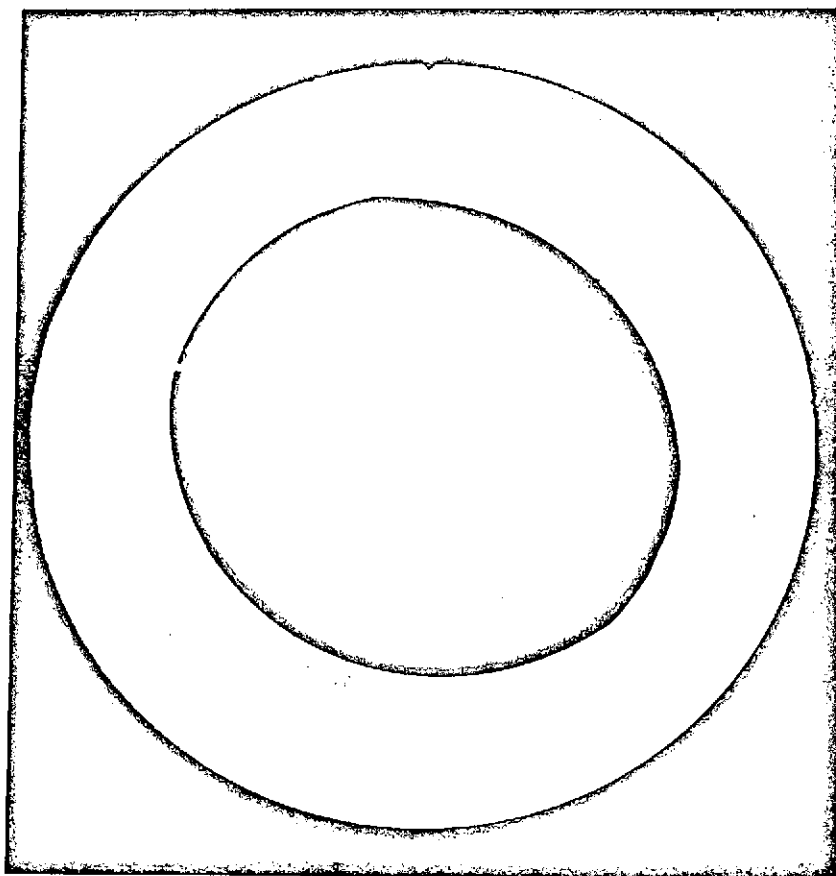
FIGURE III-2. SECTION SLS-1.4(14mm)

Figure III-2 shows the section at 14 mm and was generally typical of other sections between the ring grooves at 19 and 23 mm. Both the variation in gap width and braze alloy inside the tube are seen readily.

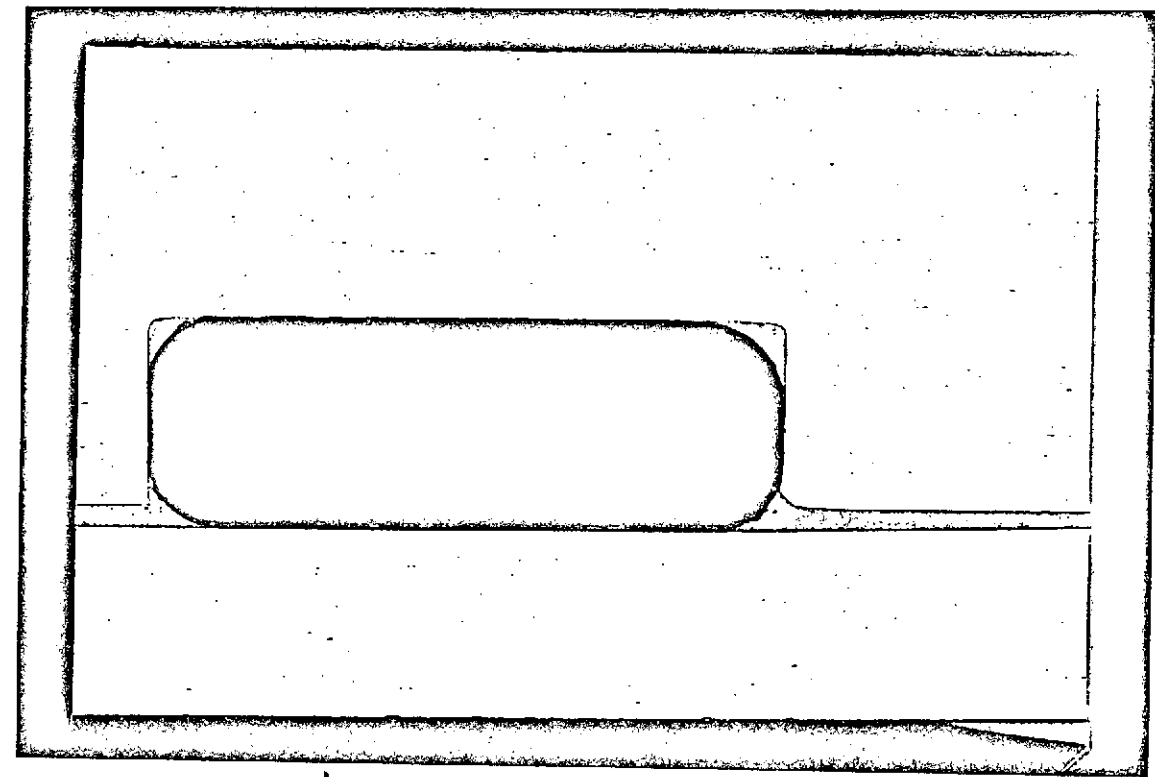
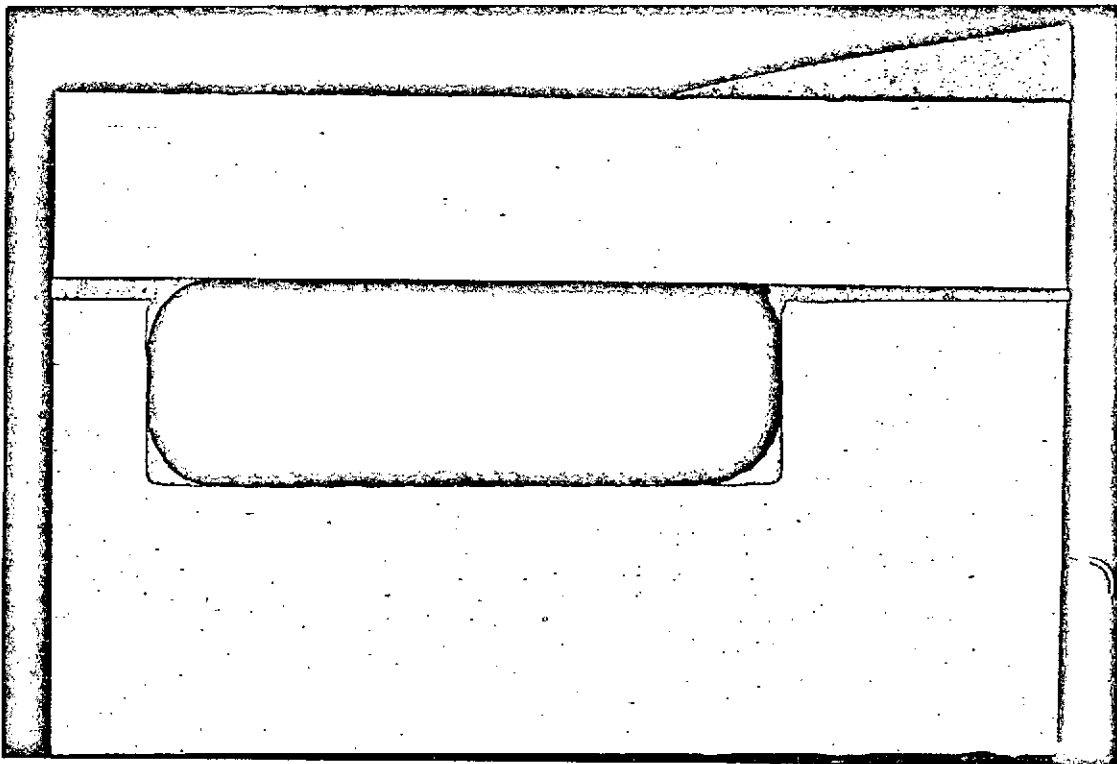
FIGURE III-3. SECTION SLS-1.3(3.5 to 10mm)

The longitudinal sections of the igniter end ring groove are shown in Figure III-3. Excellent fill of the gap area has occurred. Also, fillets have been retained both at the ends of the gap and in the remote corners of the ring groove. Portions of the excess filler metal inside the tube are also seen. Some narrowing of the joint gap at the 10-mm plane is apparent.

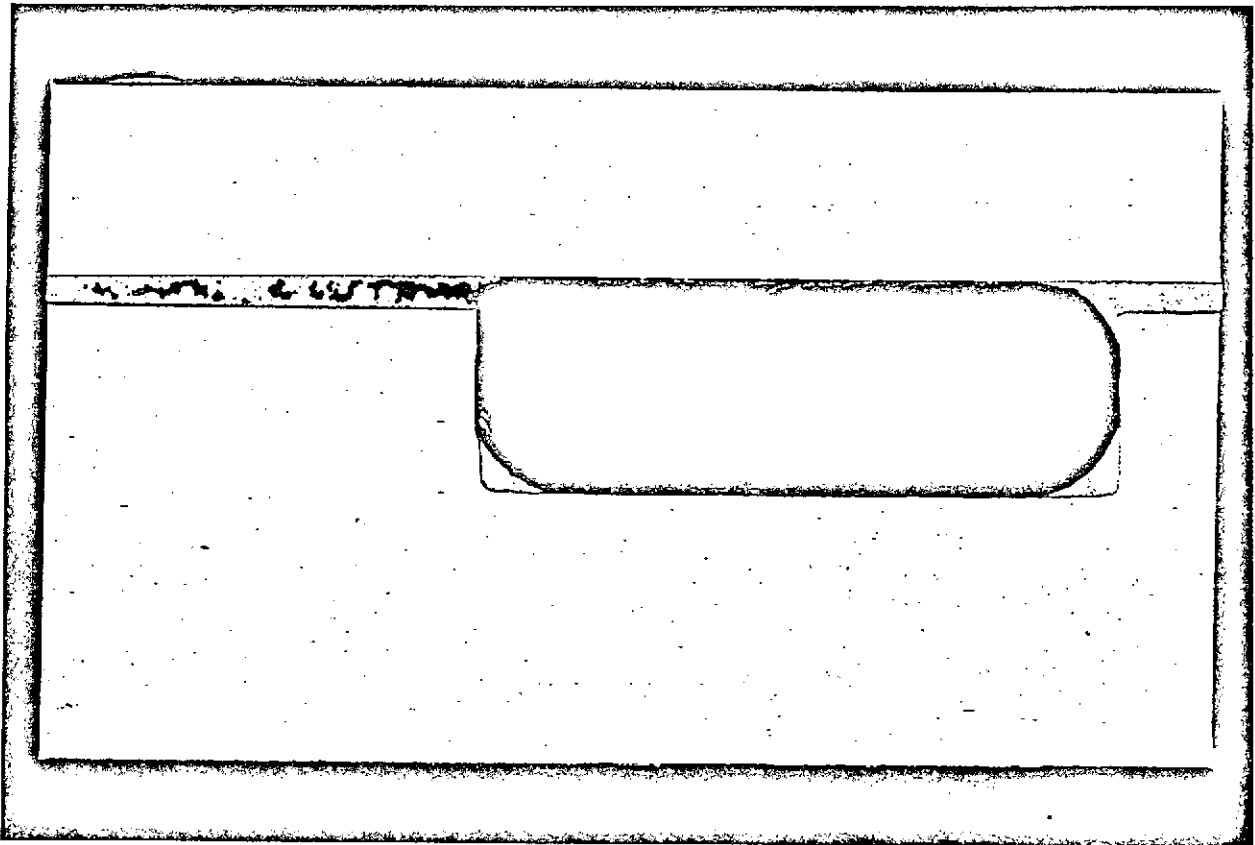
FIGURE III-4. SECTION SLS-1.7.1(23.5 to 31mm &amp; 210°)

The longitudinal section at 30 degrees between 23.5 and 31 mm is shown in Figure III-4. This section was taken through the only area containing an apparent void on the radiograph. The void area is confirmed. Again, good fillets were retained in the ring groove except where insufficient alloy was available next to the void. Higher magnification views of the void region show the typical appearance of a shrinkage void caused by draining of some of the final liquid to other regions during final solidification.

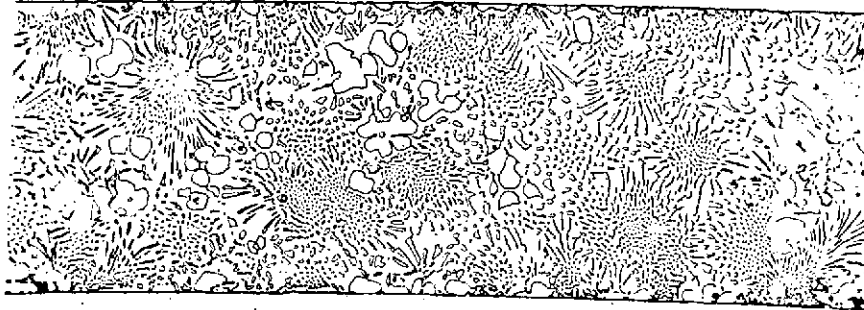
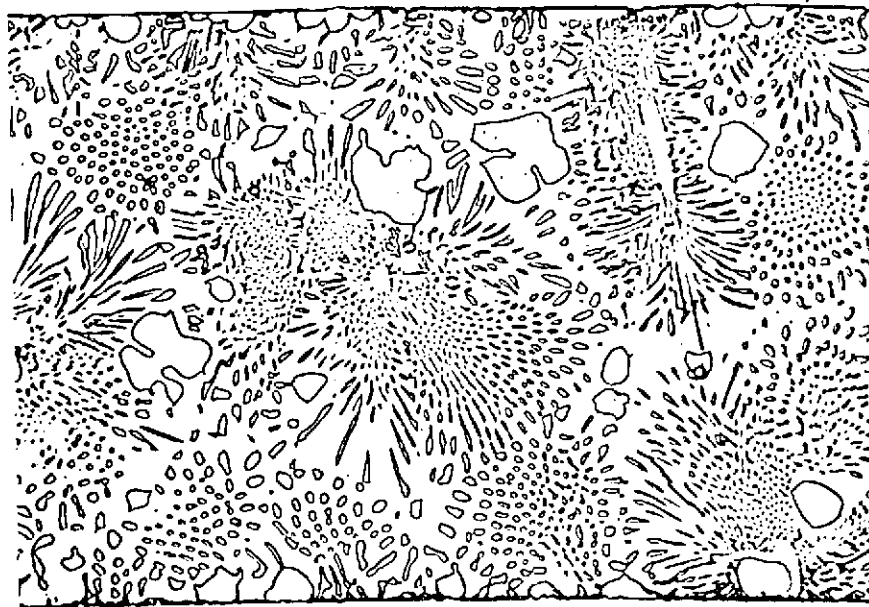
FIGURE III-5. SECTION SLS-1.4(14mm) (300°)

The braze region microstructures as shown in Figure III-5 are 250 and 500X. The phases present are essentially identical to those observed in the ground characterization specimens.

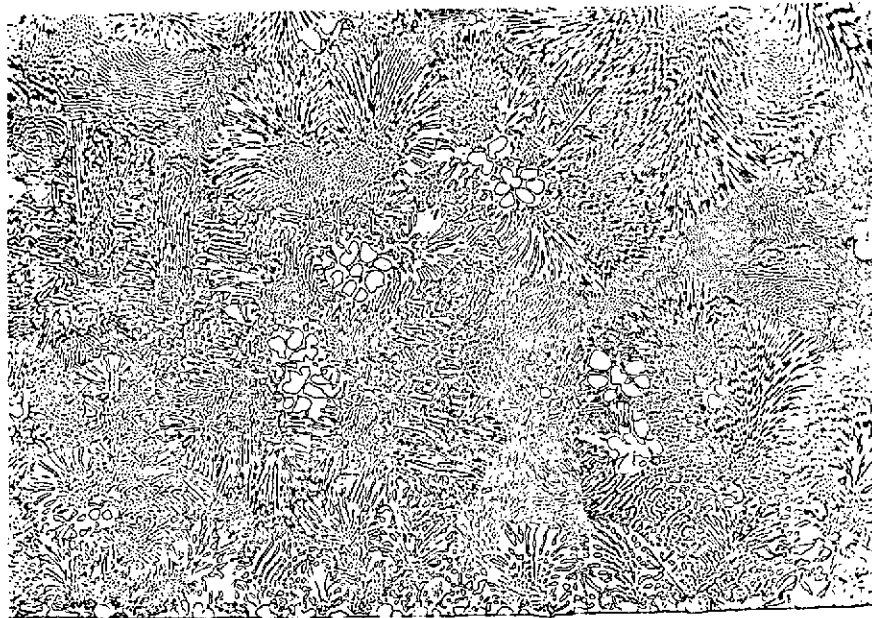
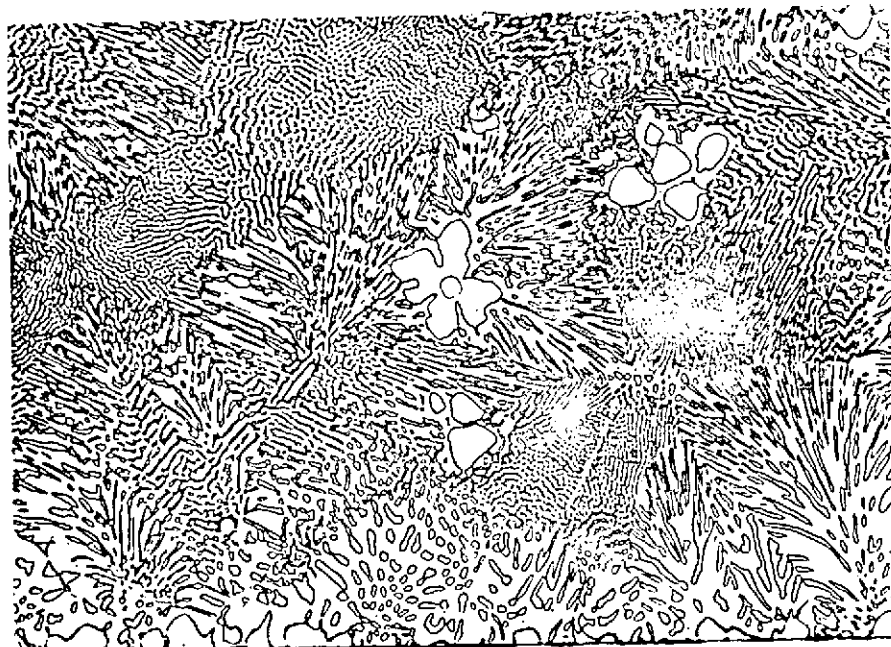
FIGURE III-6. SECTION SLS-1.4(14mm-300°)

Microstructure of the bulk braze alloy that solidified inside the tube is also similar to comparable regions in ground characterization specimens as shown in Figure III-6.

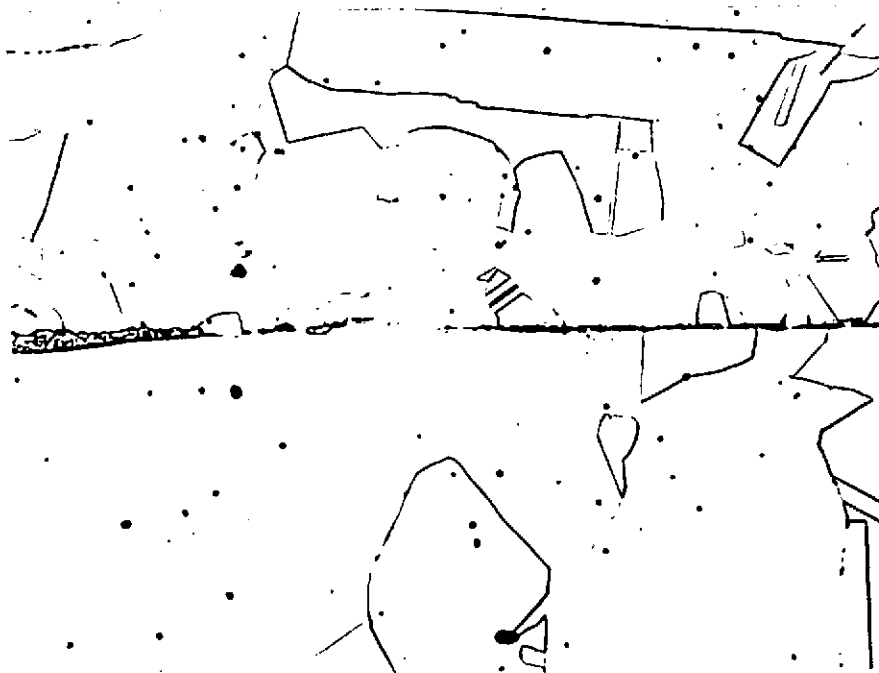
FIGURE III-7.. SECTION SLS-1.4(14mm-0°)

Some regions of the sleeve-tube interface where the gap was very tight are shown in Figure III-7. These regions were examined in some detail to determine if a solid-state weld existed. Figure III-7b shows the same region after etching and discloses evidence of grain growth across the interface needed to substantiate that solid-state welding (diffusion bonding) did indeed occur.

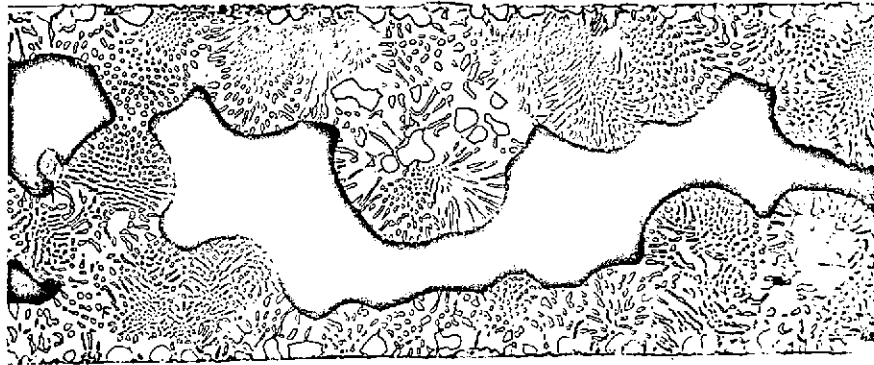
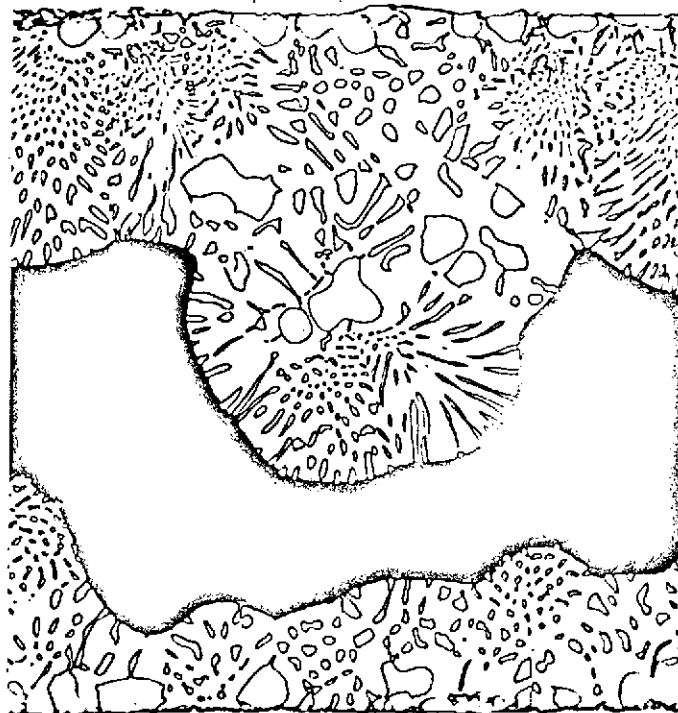
FIGURE III-8 SECTION SLS-1.7.1(24mm &amp; 210

Microstructures in the area contain a void is shown in Figure III-8. The void shape is similar to that of comparable regions examined in ground characterization specimens. The voids are a result of draining of the area during the last stages of solidification.

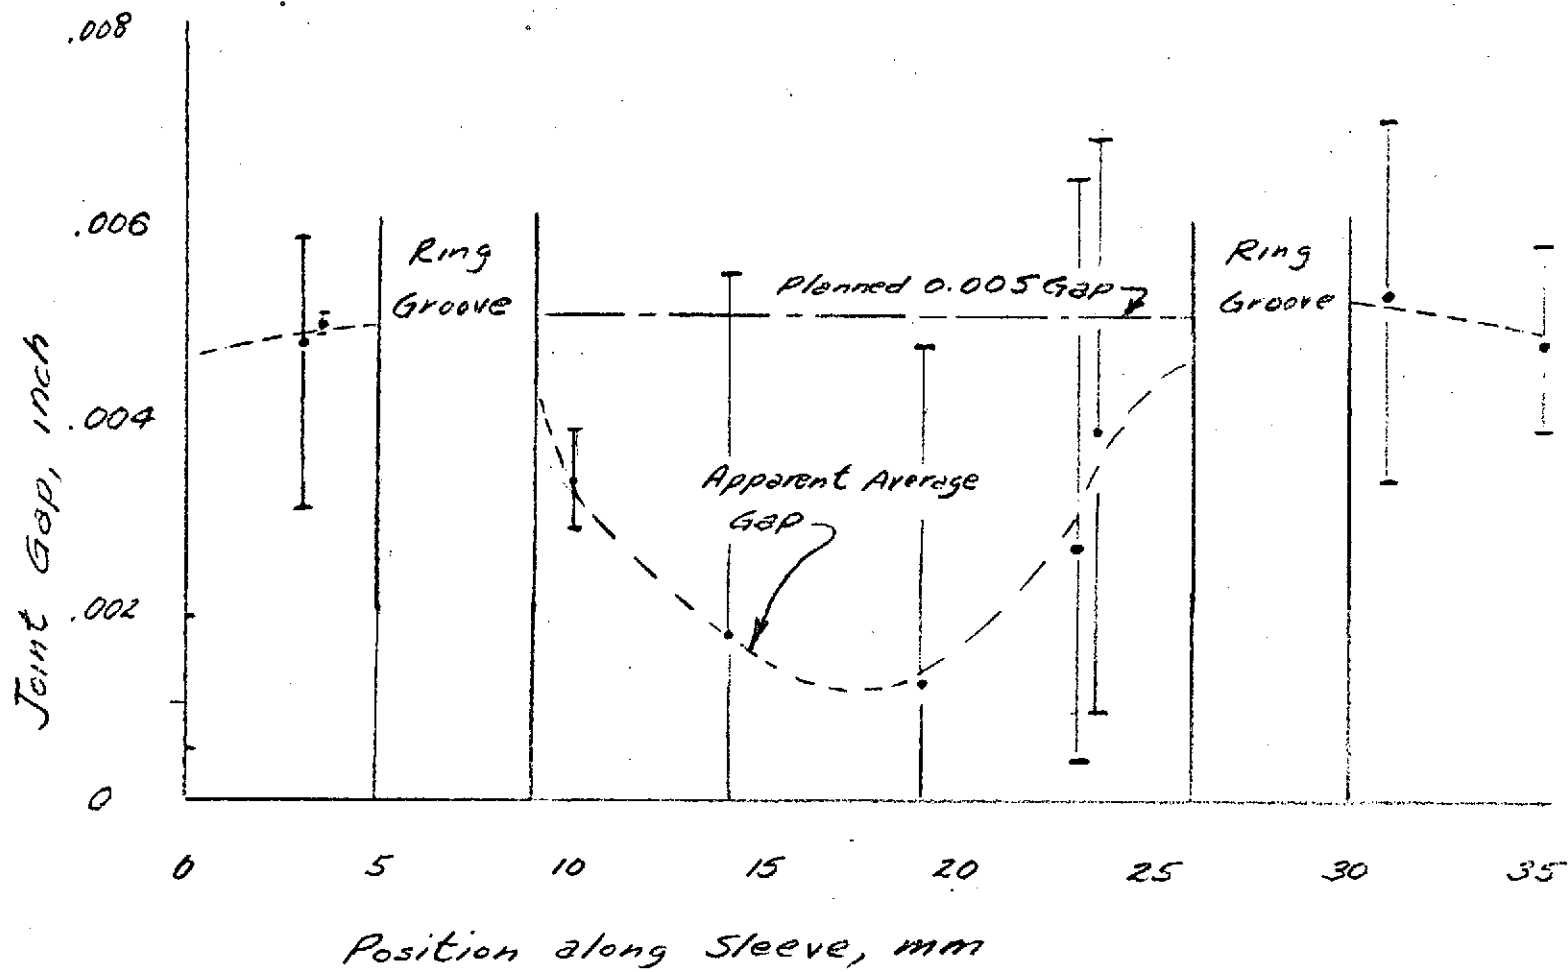
FIGURE III-9 PLOT OF JOINT GAP MEASUREMENTS

Measurements of both the joint gap and diameters at various points were made in attempts to resolve the gap variations observed. The joint gap measurements are shown in Table III-2. The measured gap ranged from 0 to a maximum of 0.007 in., with most measurements being less than the intended 0.005-in. gap. Average gaps at each sectioning plane are plotted in Figure III-9, to better illustrate this variation. Diameter measurements of individual sections have indicated some minor out of round conditions, but have not been helpful in establishing the basic cause of the gap variations.
